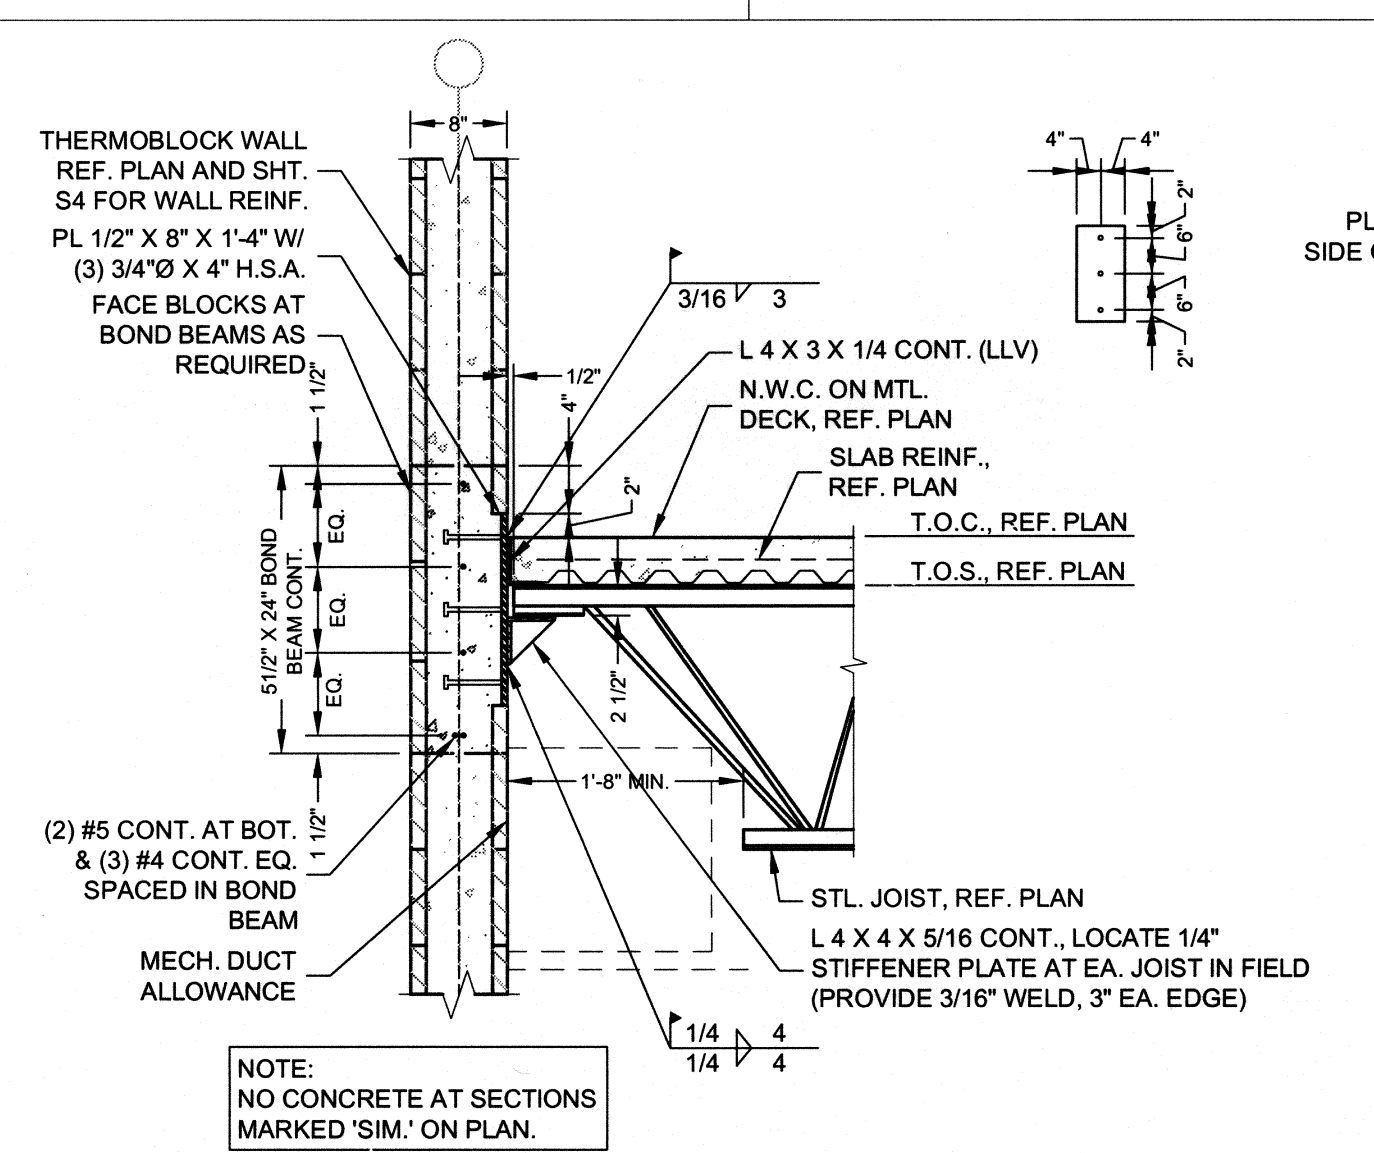
1 JOIST BEARING DETAIL AT WALL  
N.T.S.

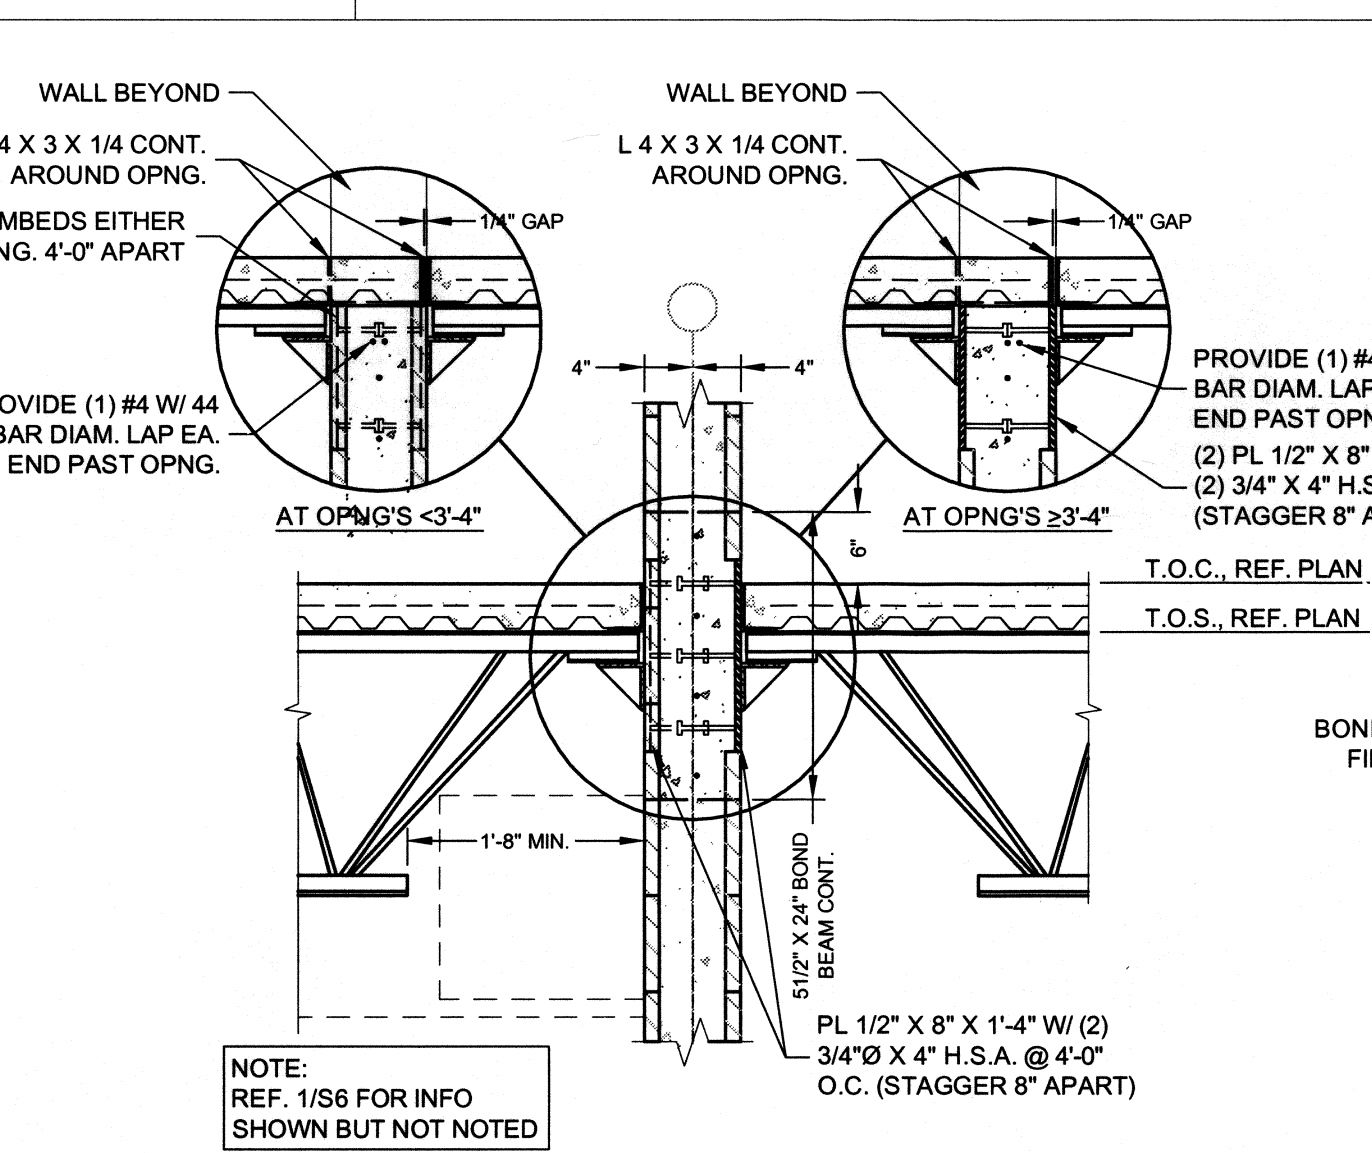
2 JOIST BEARING AT INTERIOR WALL  
N.T.S.

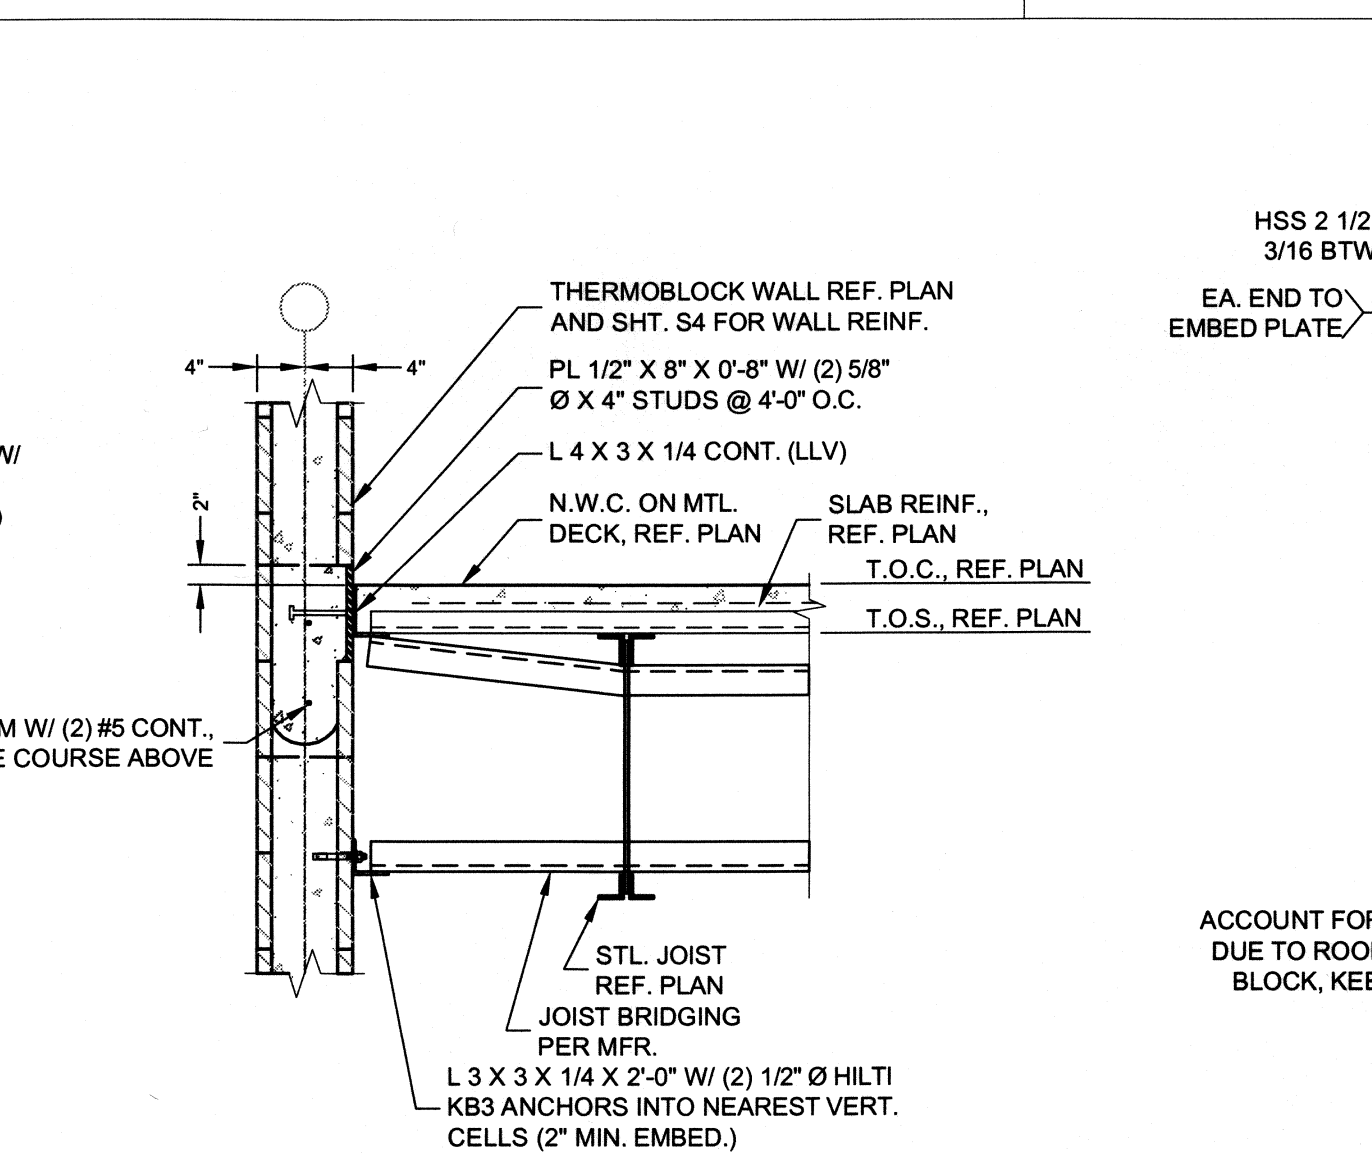
3 DECK SUPPORT DETAIL  
N.T.S.

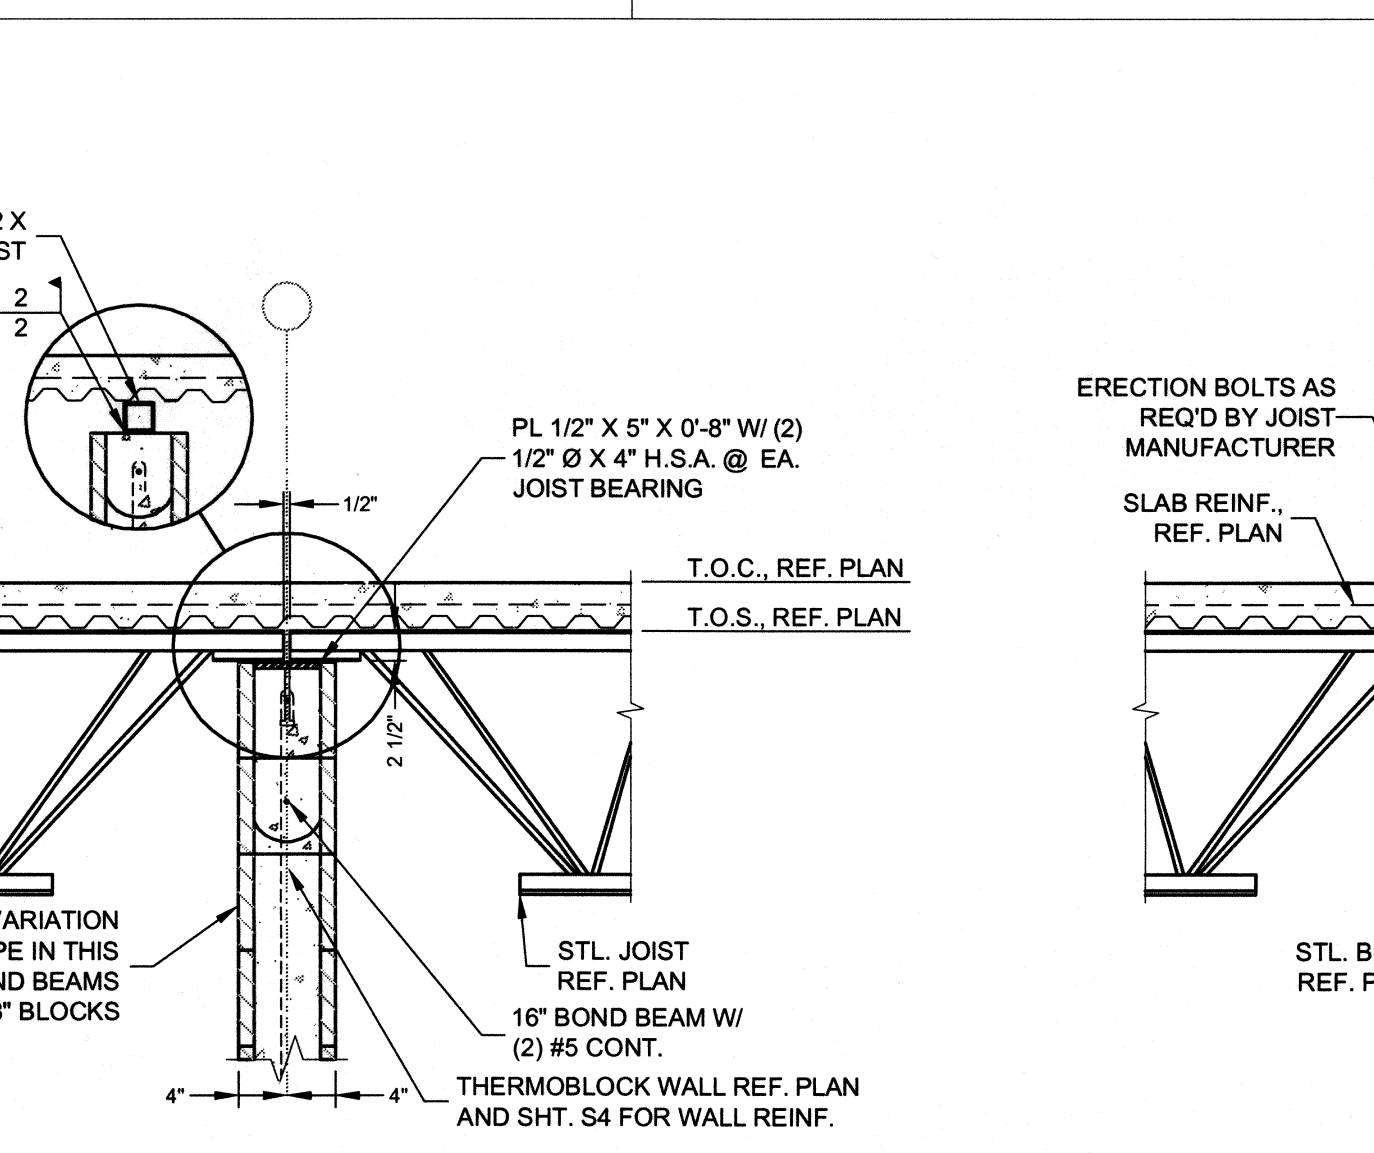
4 JOIST BEARING AT TOP OF WALL  
N.T.S.

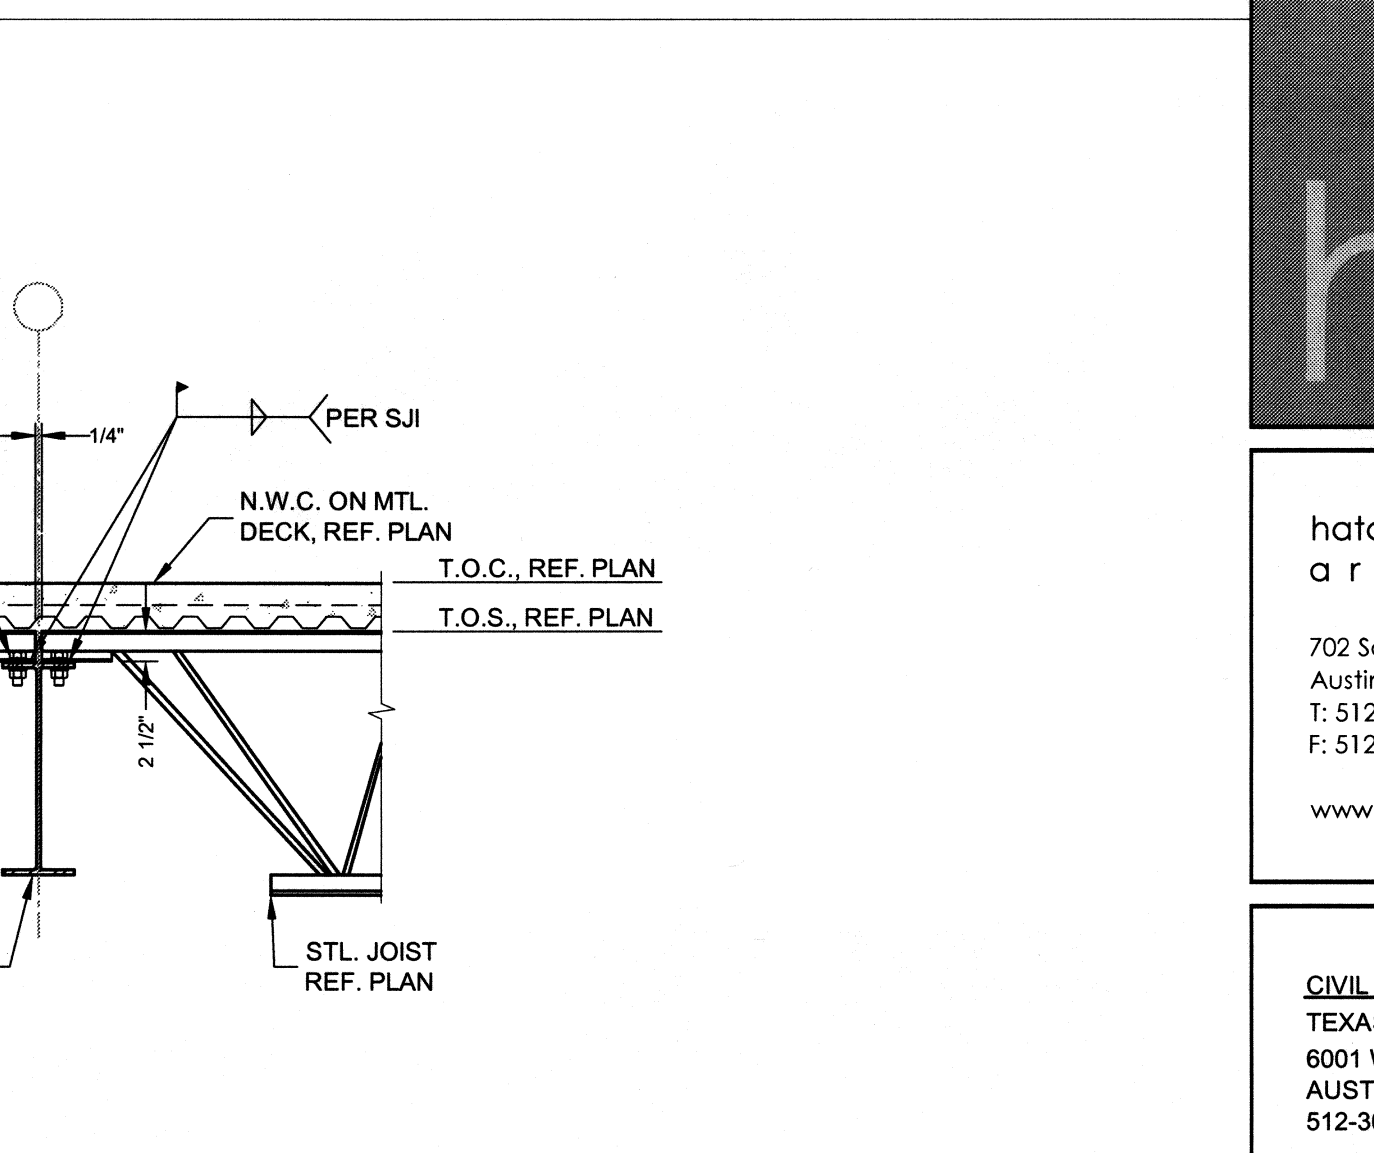
5 JOIST BEARING AT BEAM  
N.T.S.

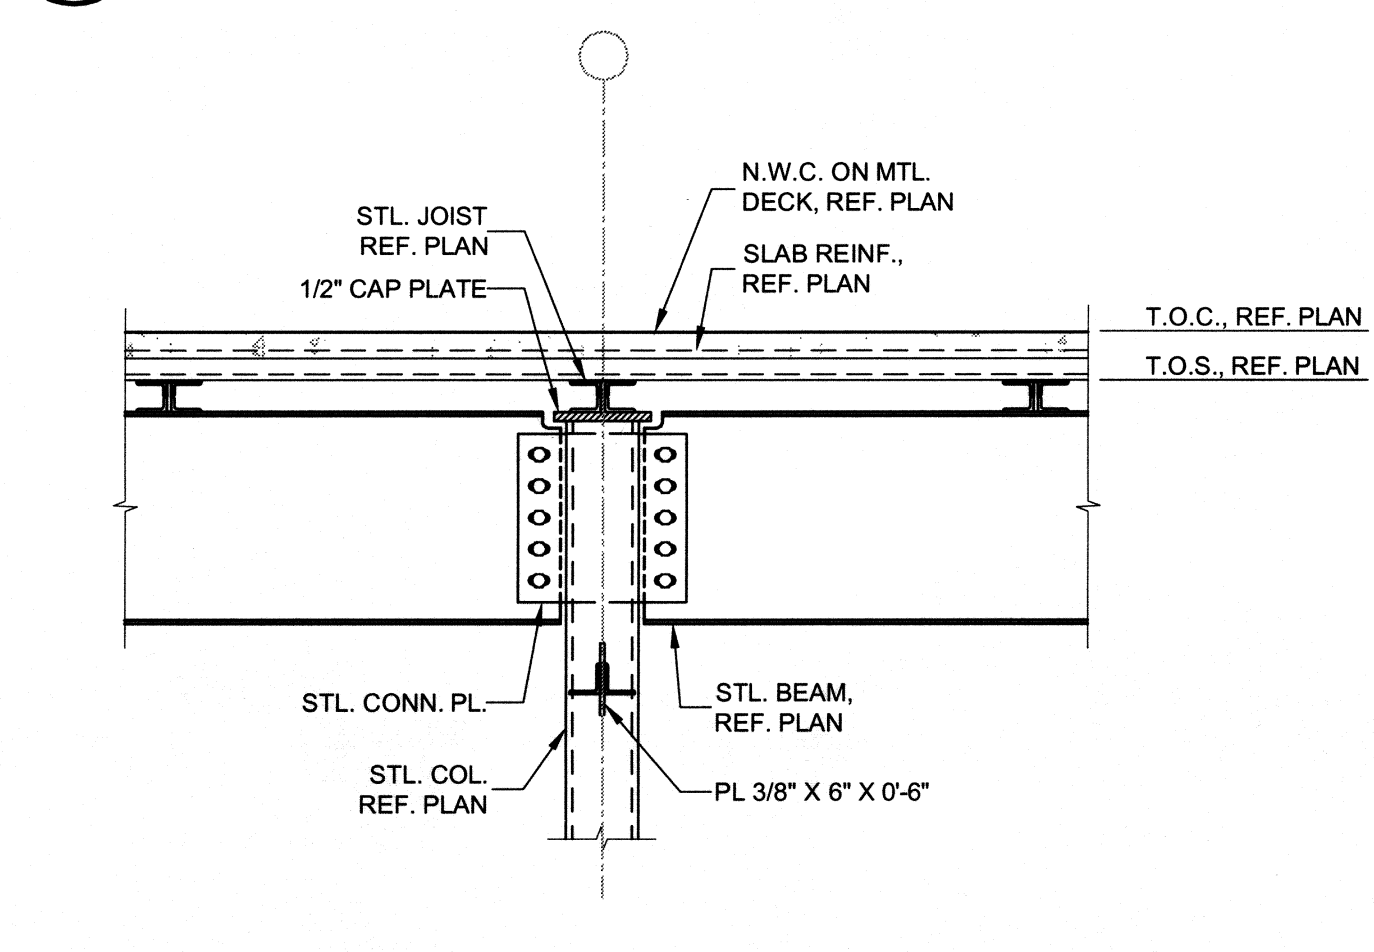
6 BEAM TO COLUMN CONN.  
N.T.S.

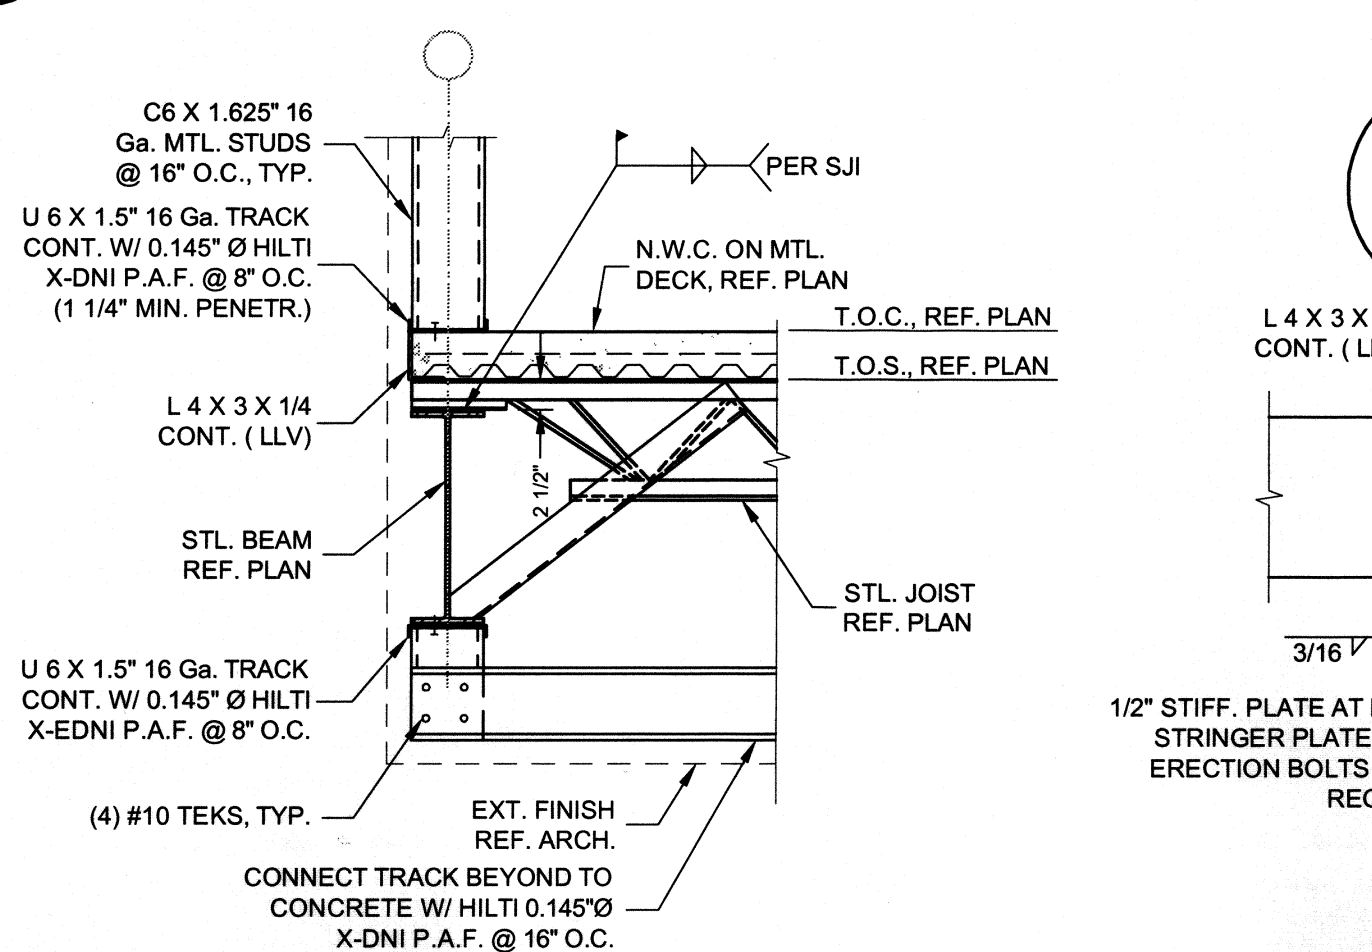
7 EXTERIOR BEAM AT CANOPY  
N.T.S.

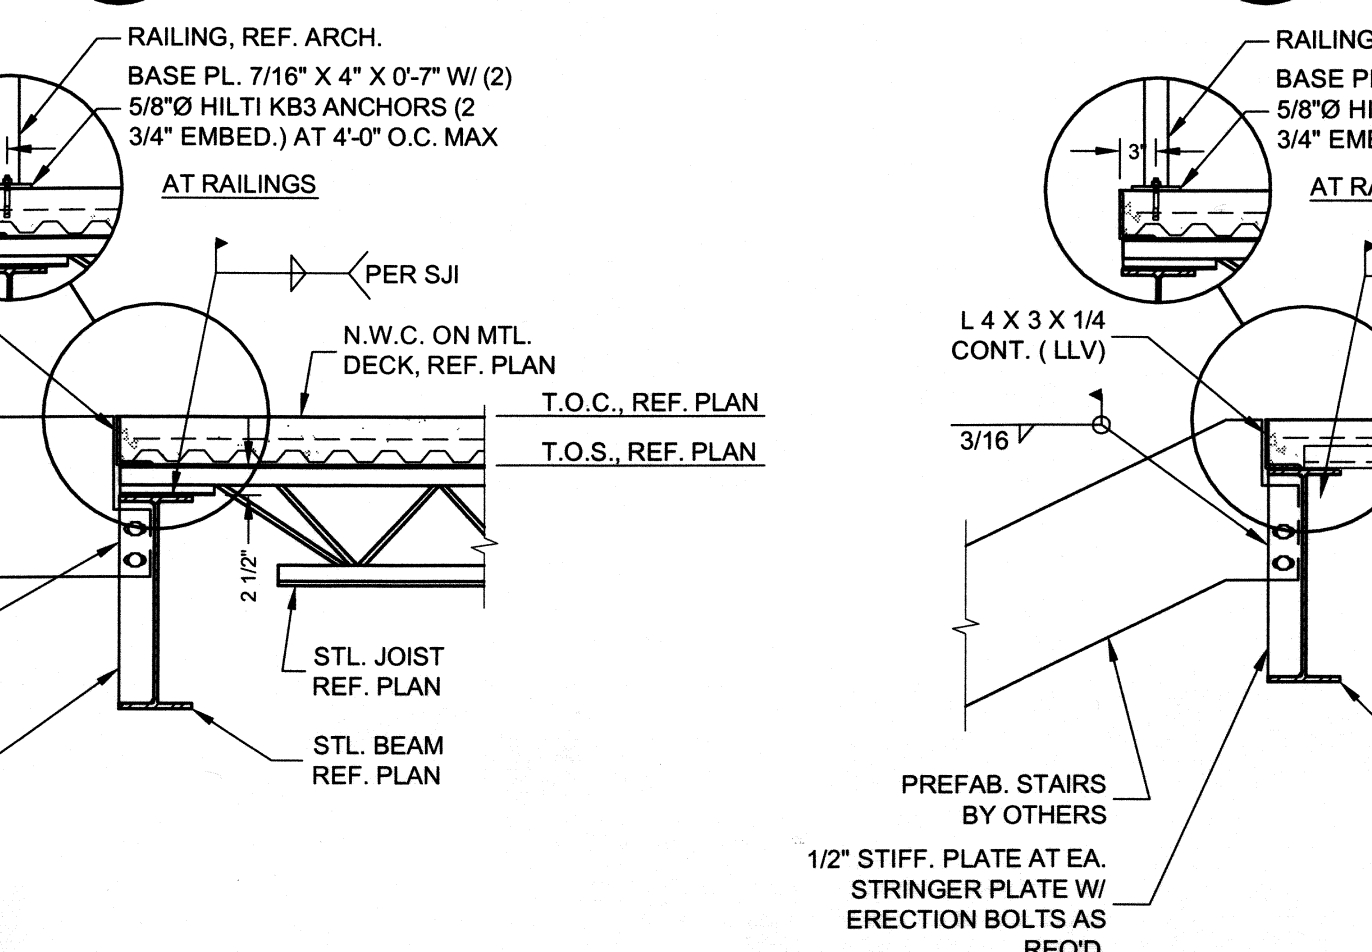
8 EDGE BEAM AT STAIR LANDING  
N.T.S.

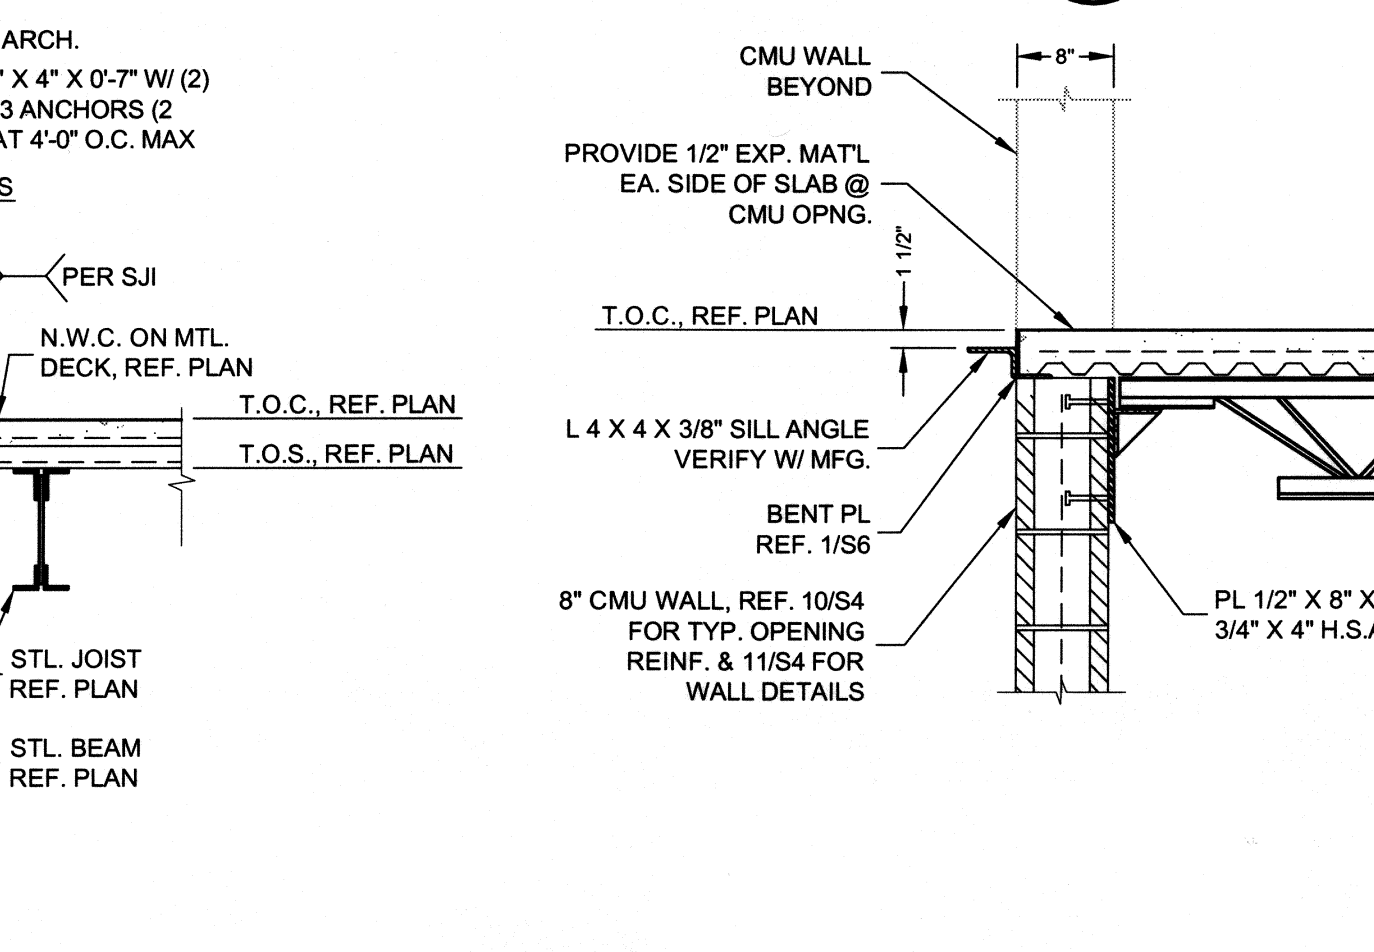
9 EDGE BEAM AT STAIR LANDING  
N.T.S.

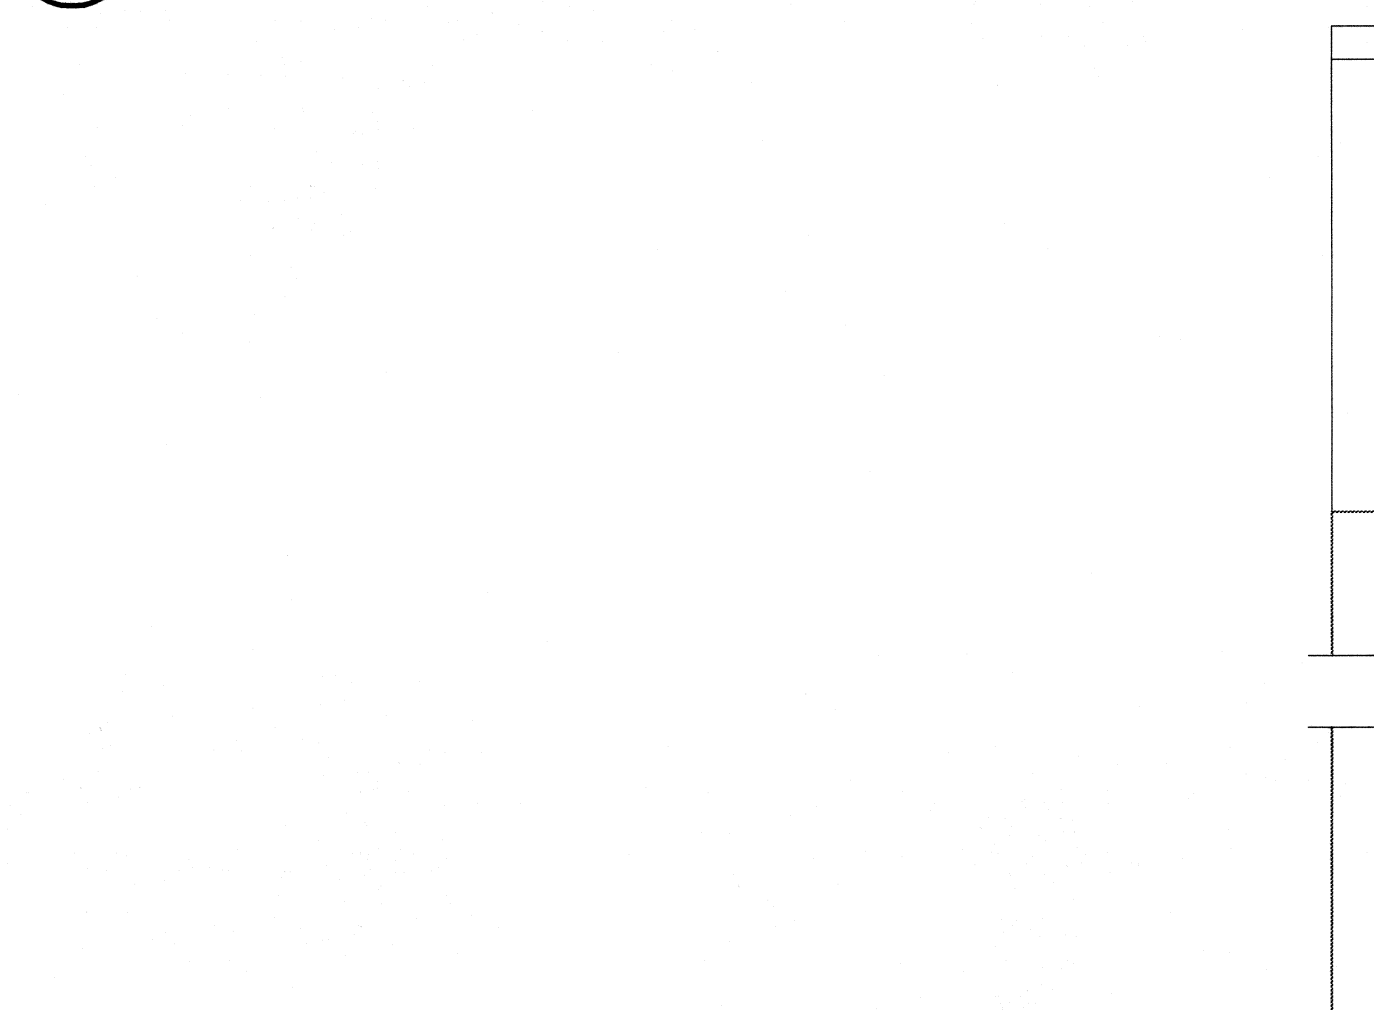
11 TYPICAL MEP CHASE OPNG.  
N.T.S.

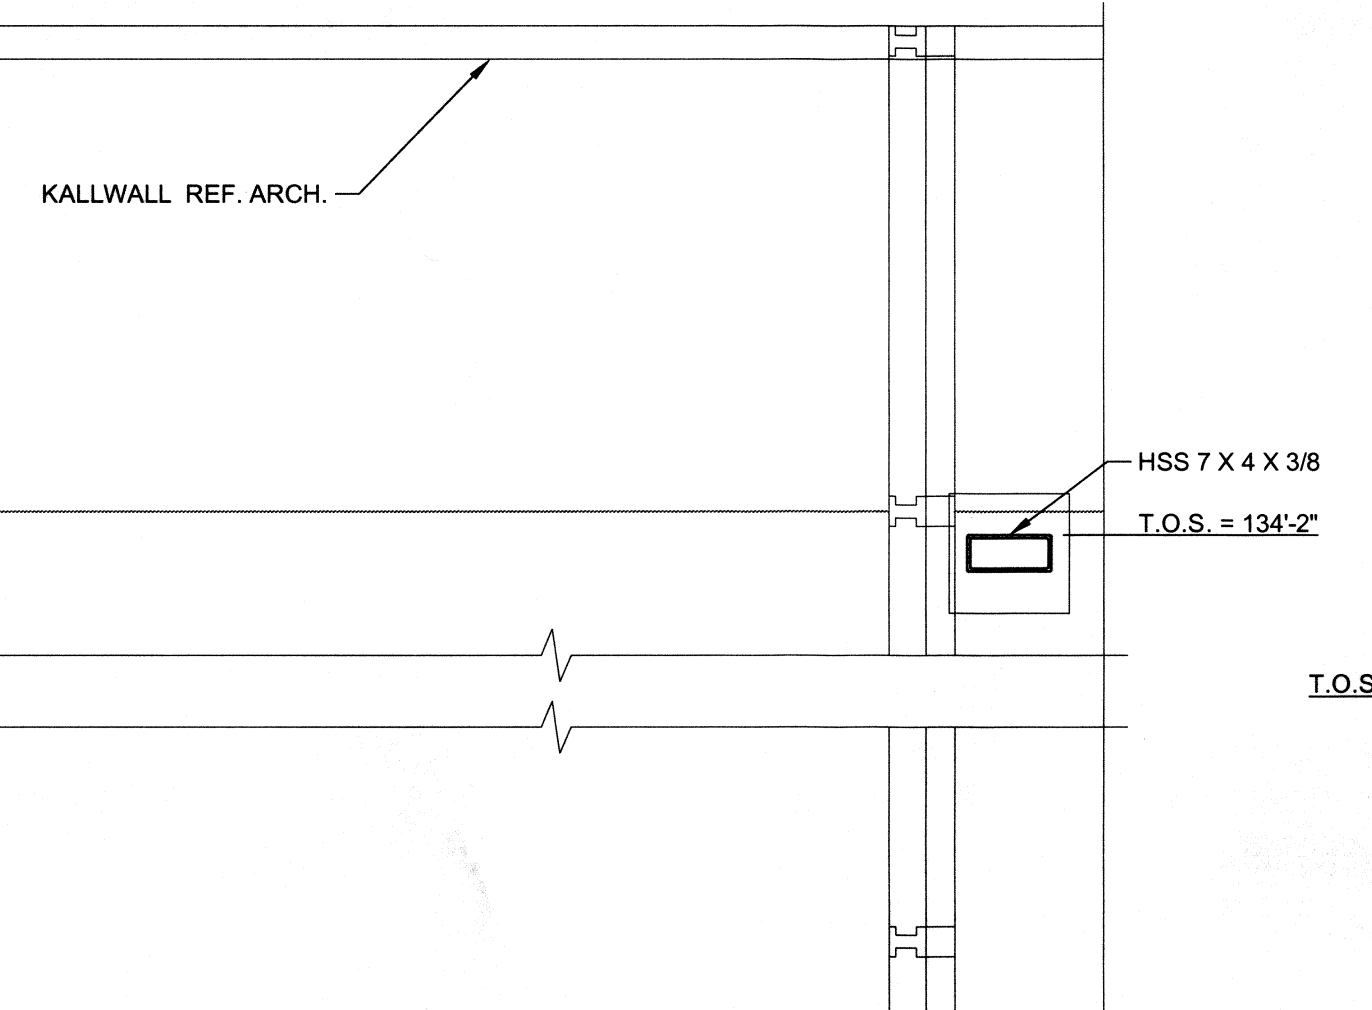
12 ENTRY DETAIL  
N.T.S.

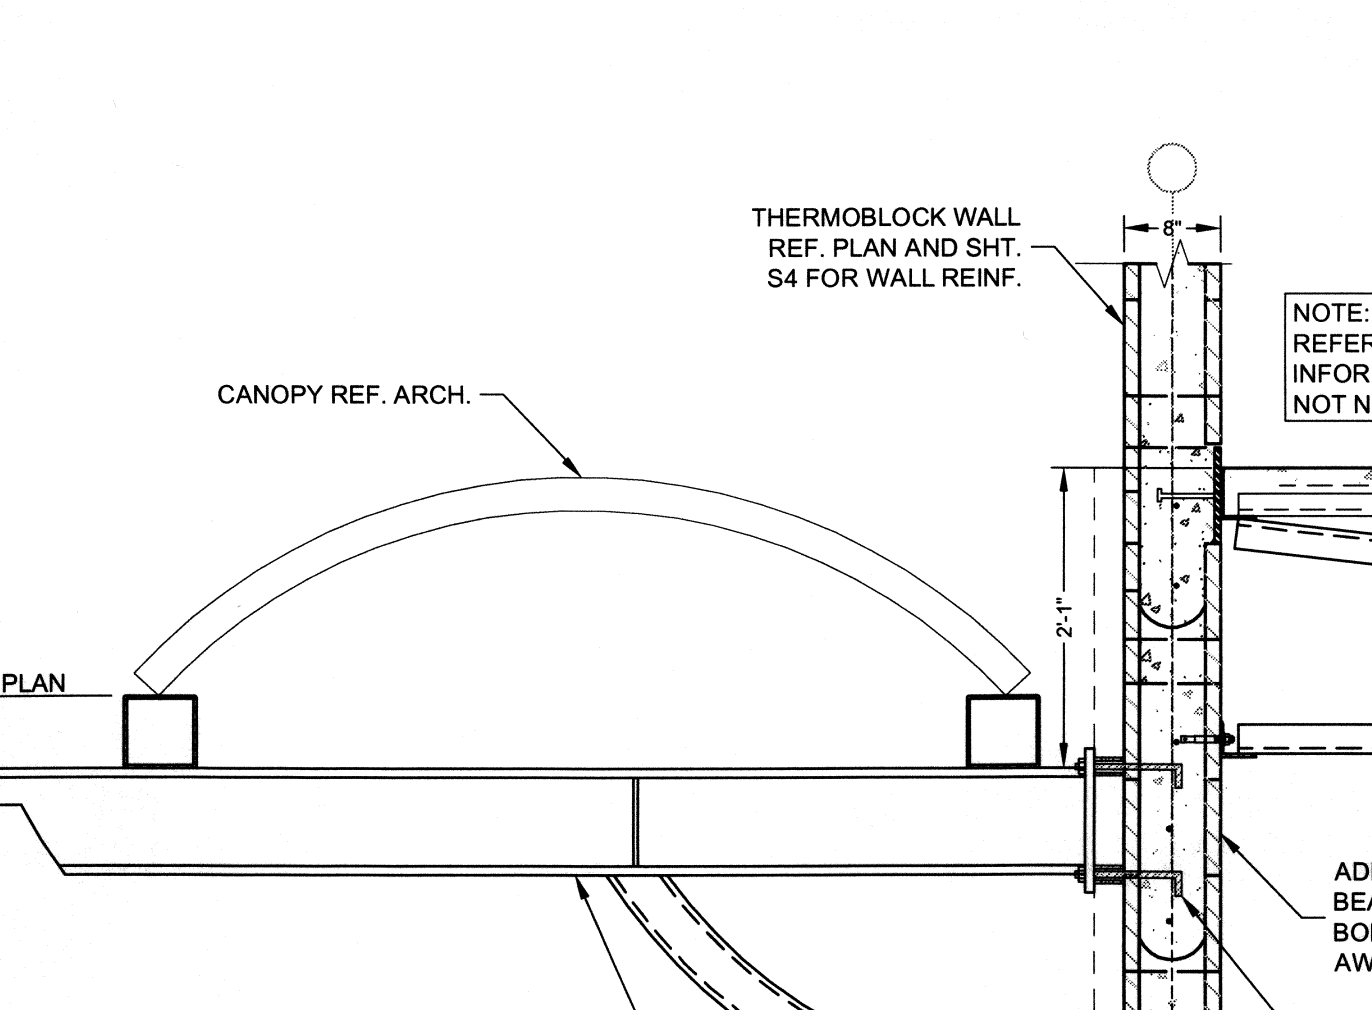
13 AWNING DETAIL  
N.T.S.

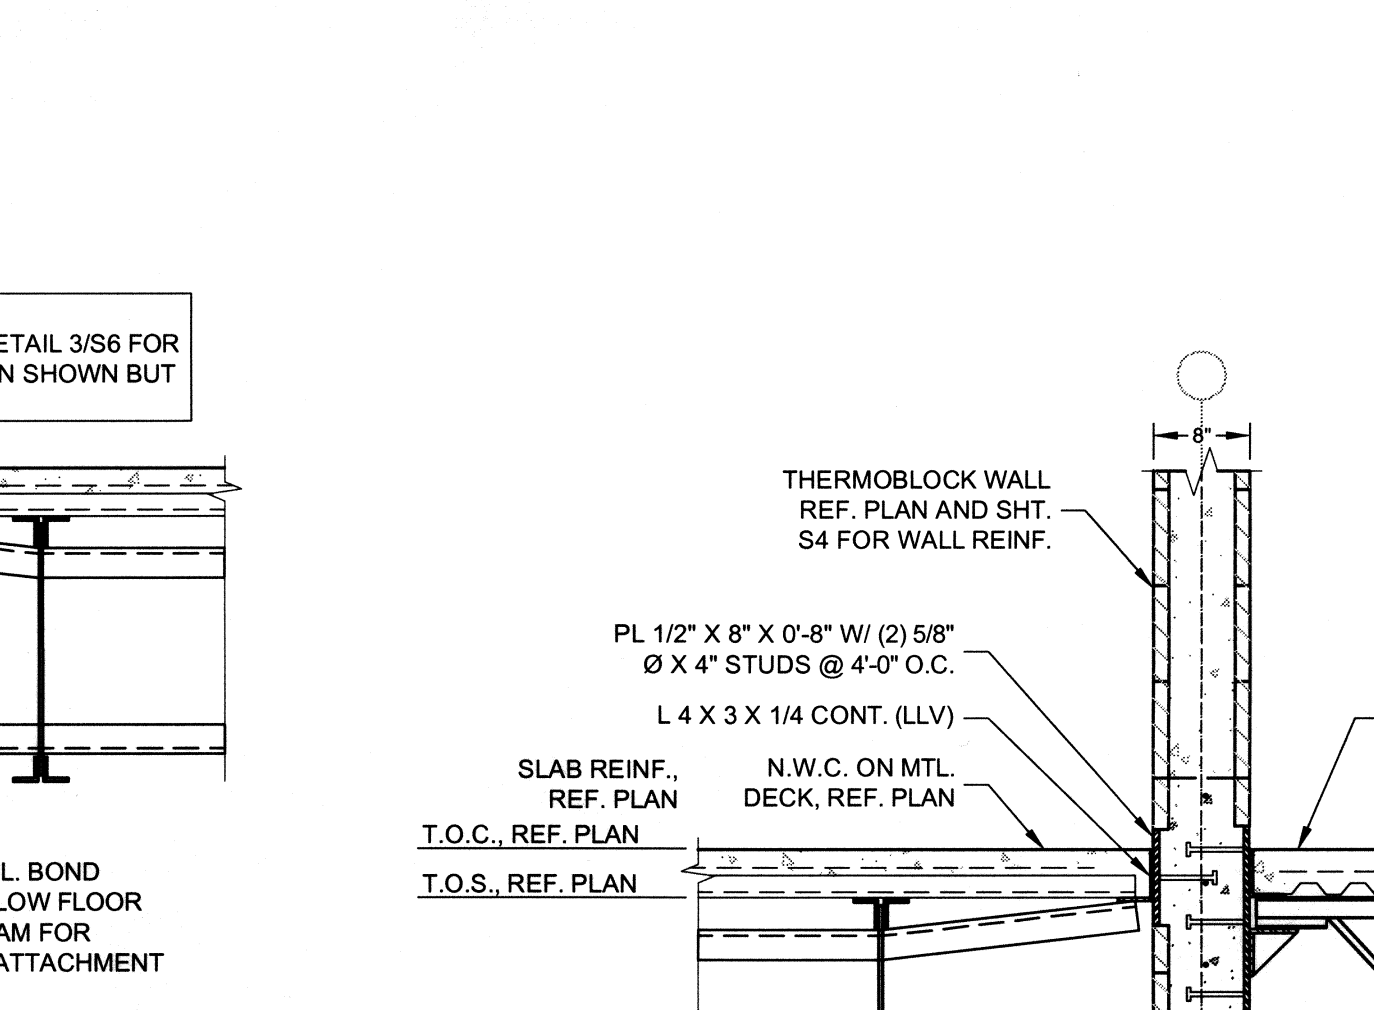
14 JOIST BEARING DETAIL  
N.T.S.

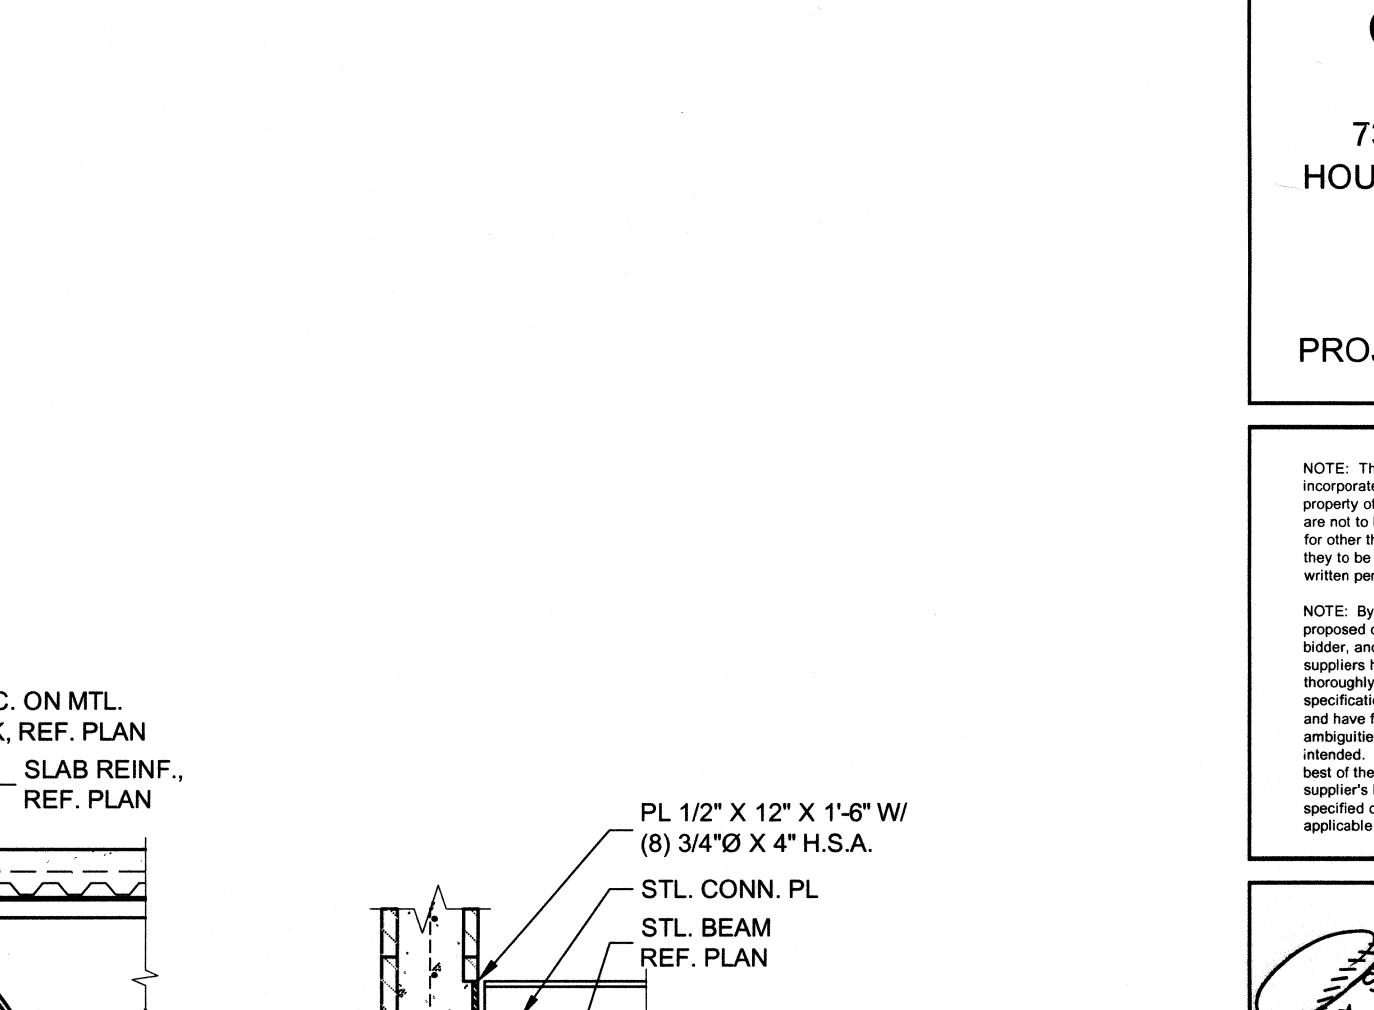
15 TYP. BEAM CONN. DETAIL  
N.T.S.

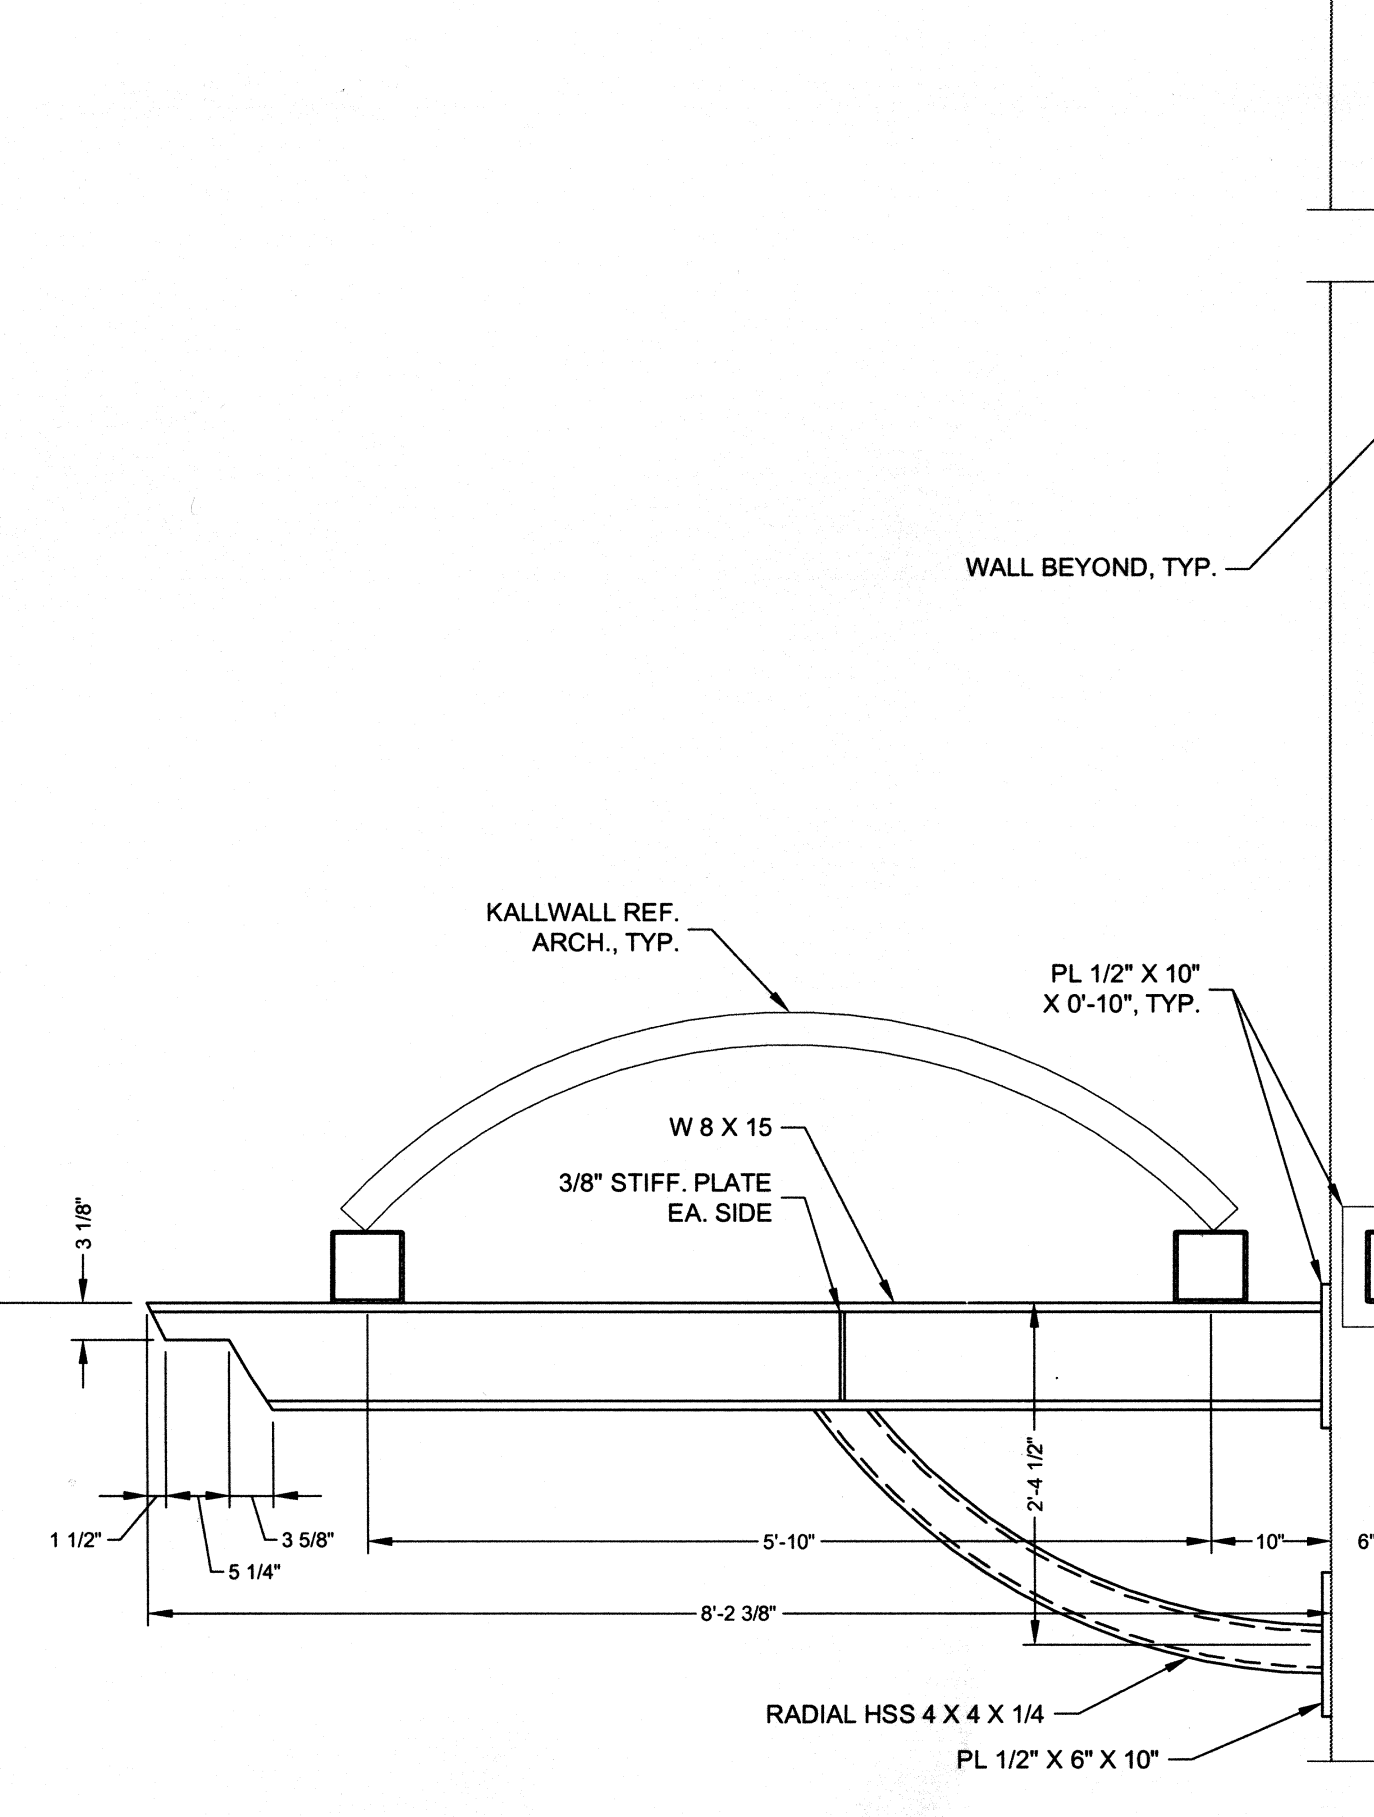
16 SPECIAL LANDING DETAIL  
N.T.S.
