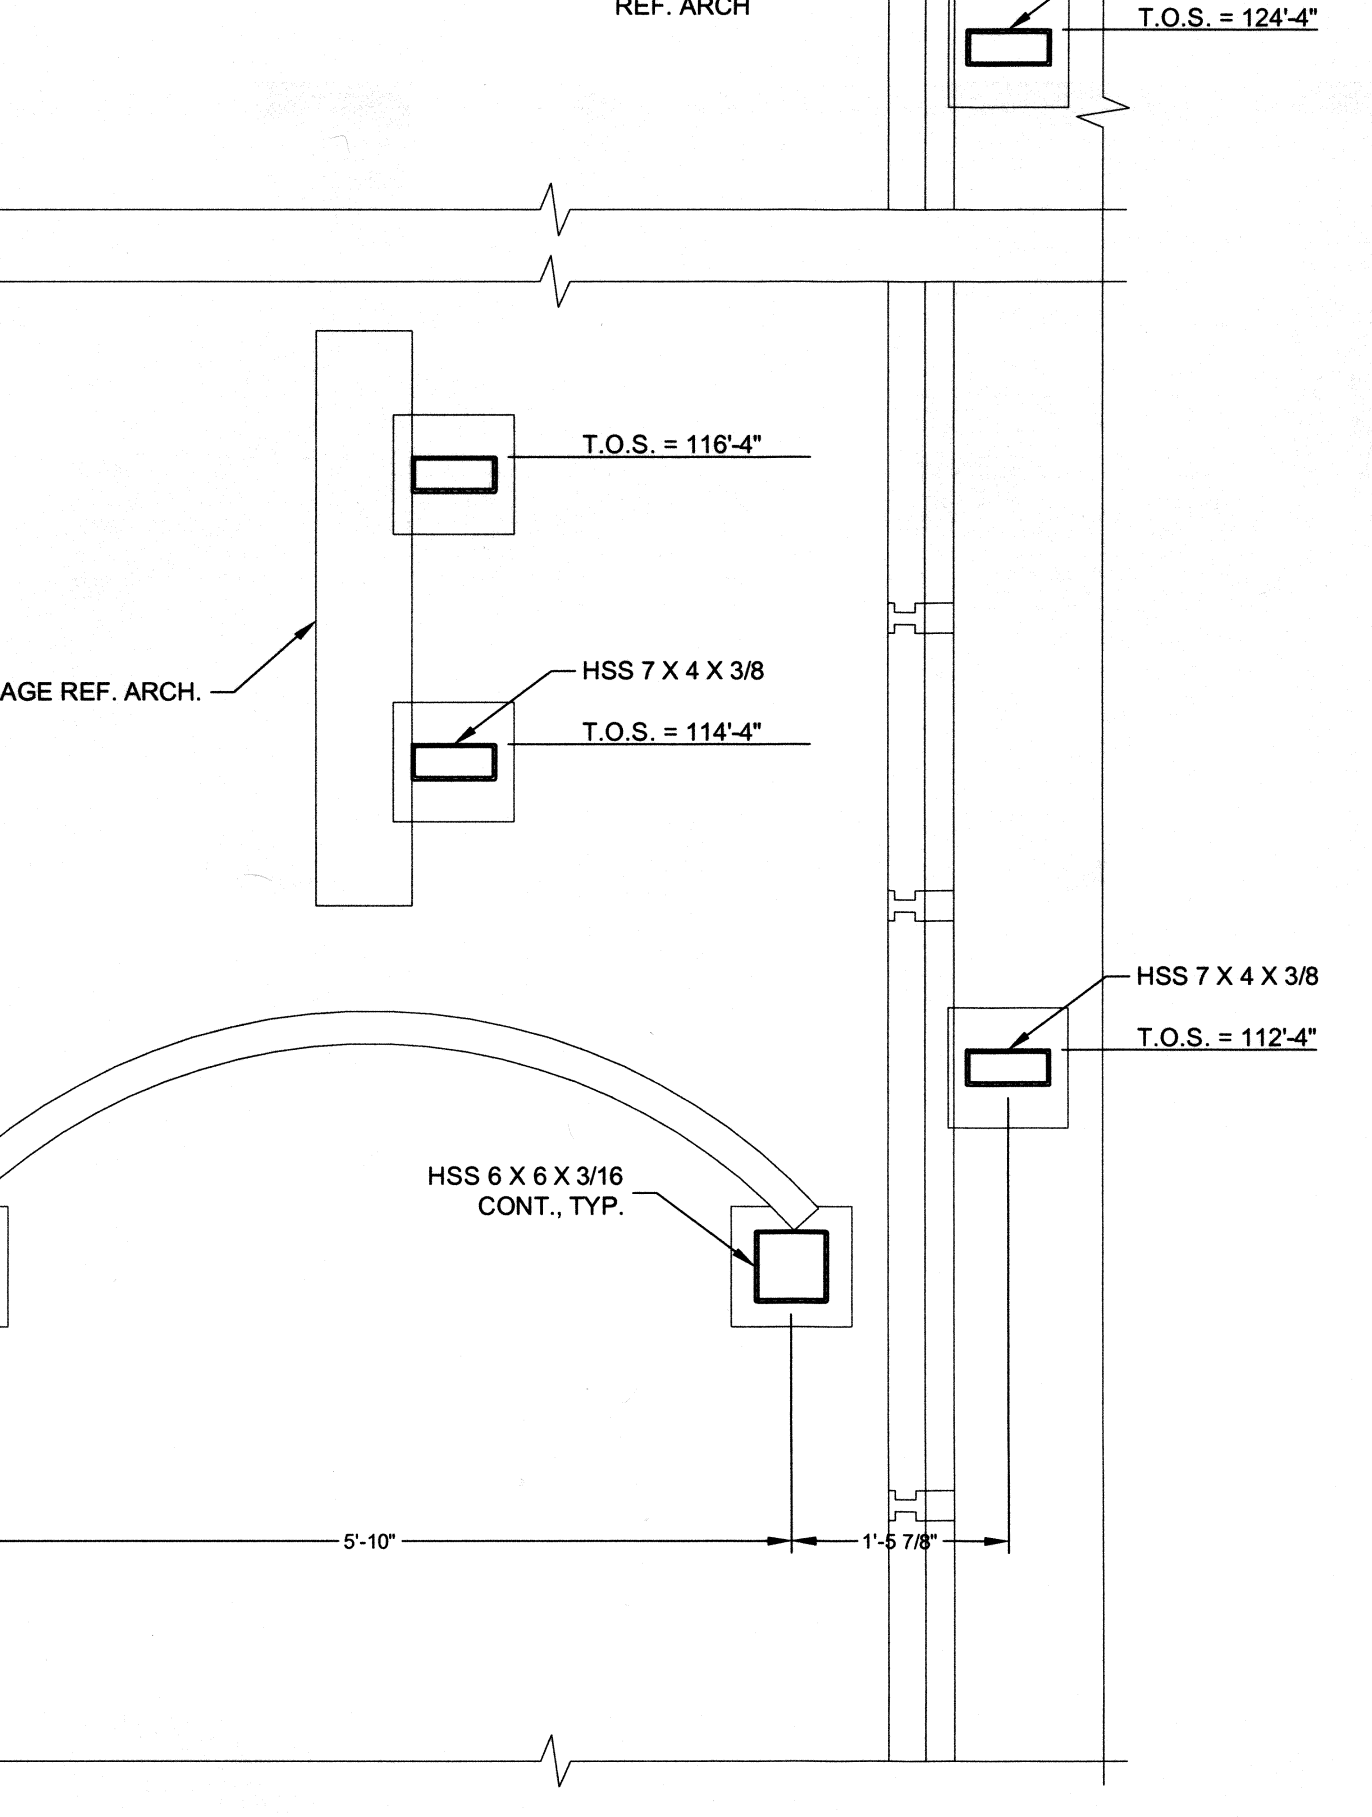
17 SLOPED ROOF  
N.T.S.

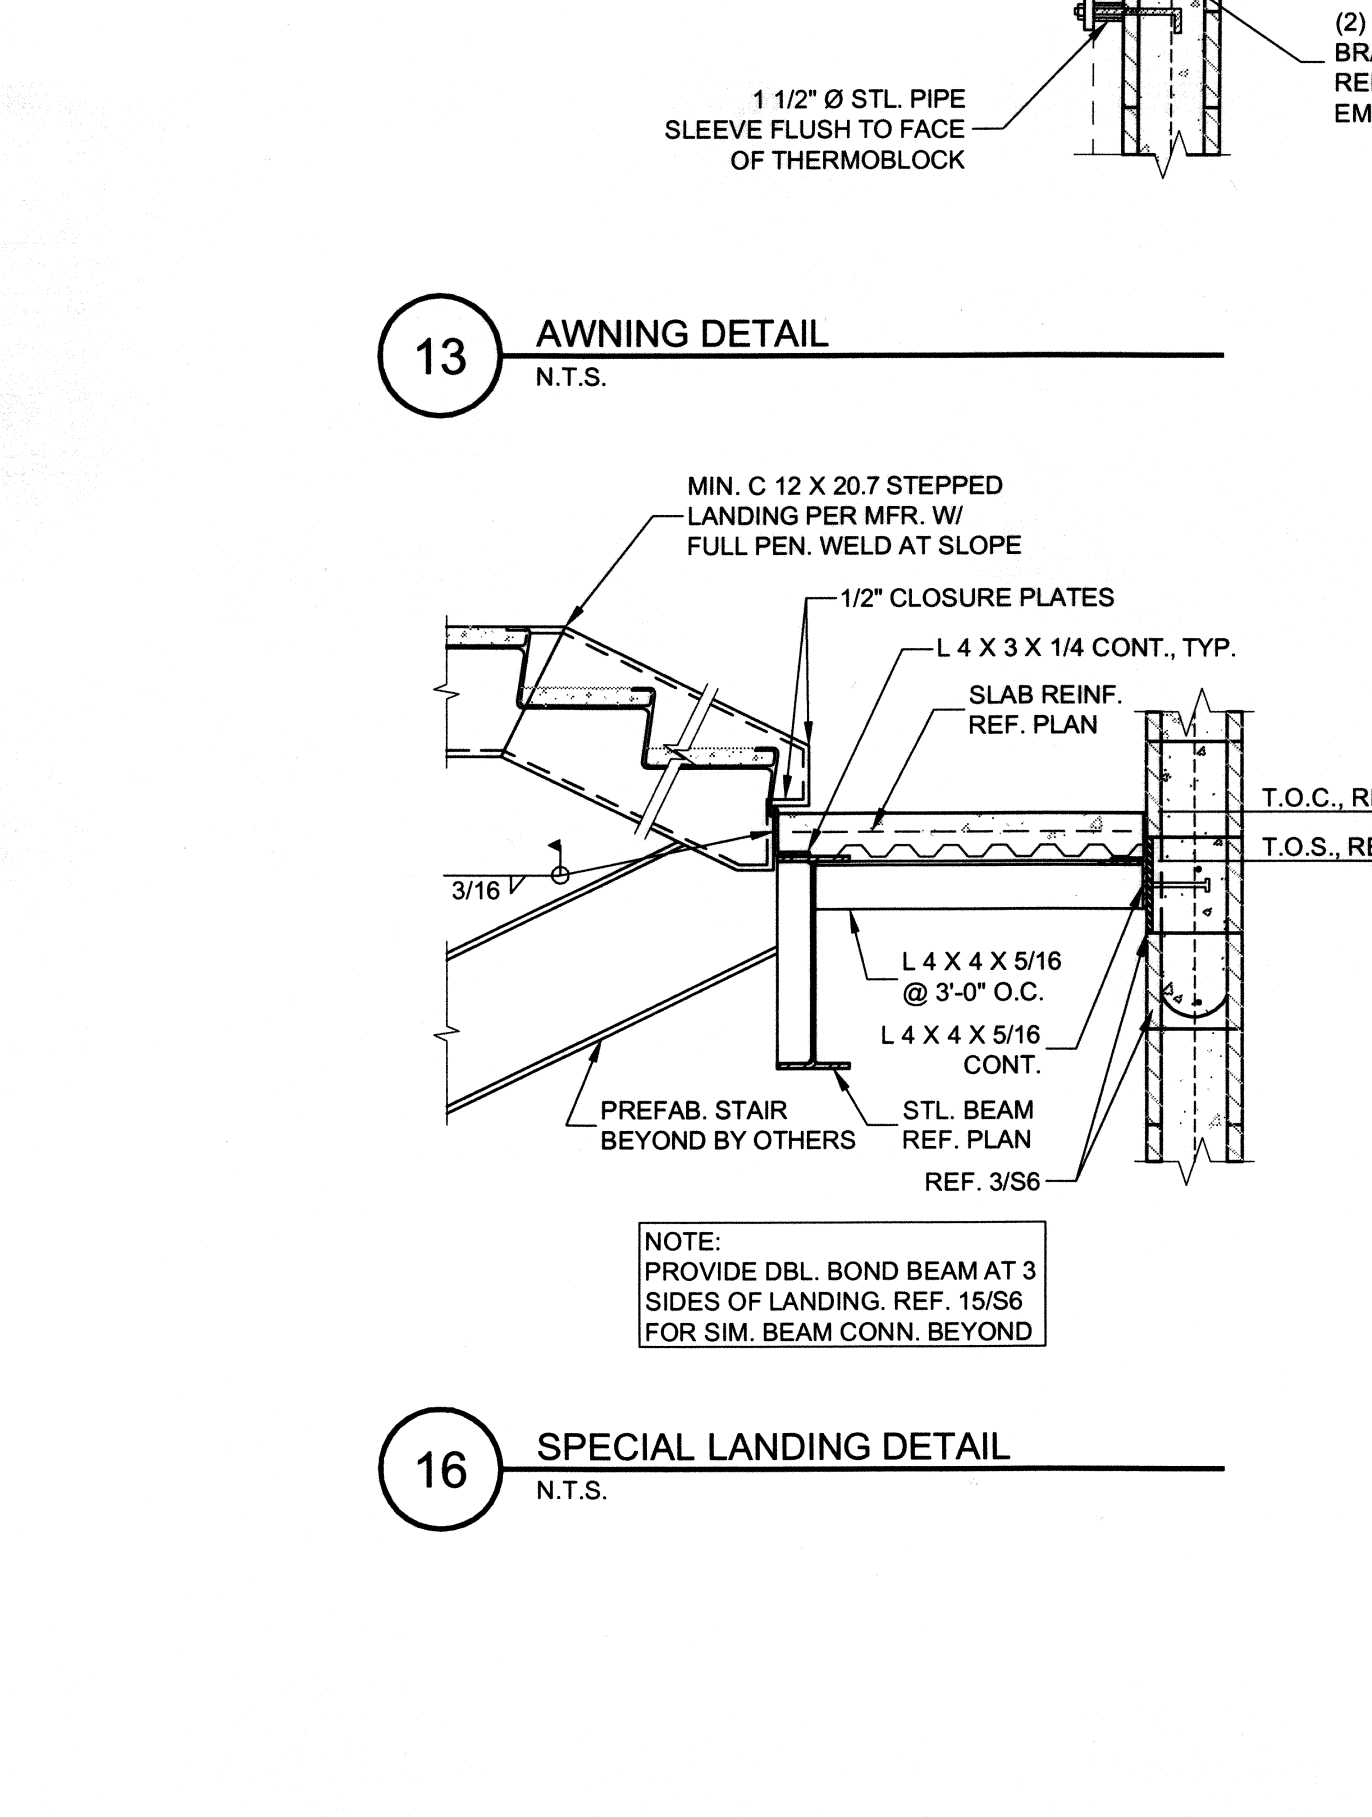
18 HANDRAIL CONN.  
N.T.S.
